Aerial view of a corner of Rokko Island. The light-colored material on the paved surface (lower left corner) is sand that boiled to the surface as a consequence of liquefaction. The island is ringed with large gravity caisson "quay" walls, and the surrounding water is about 15 m deep.

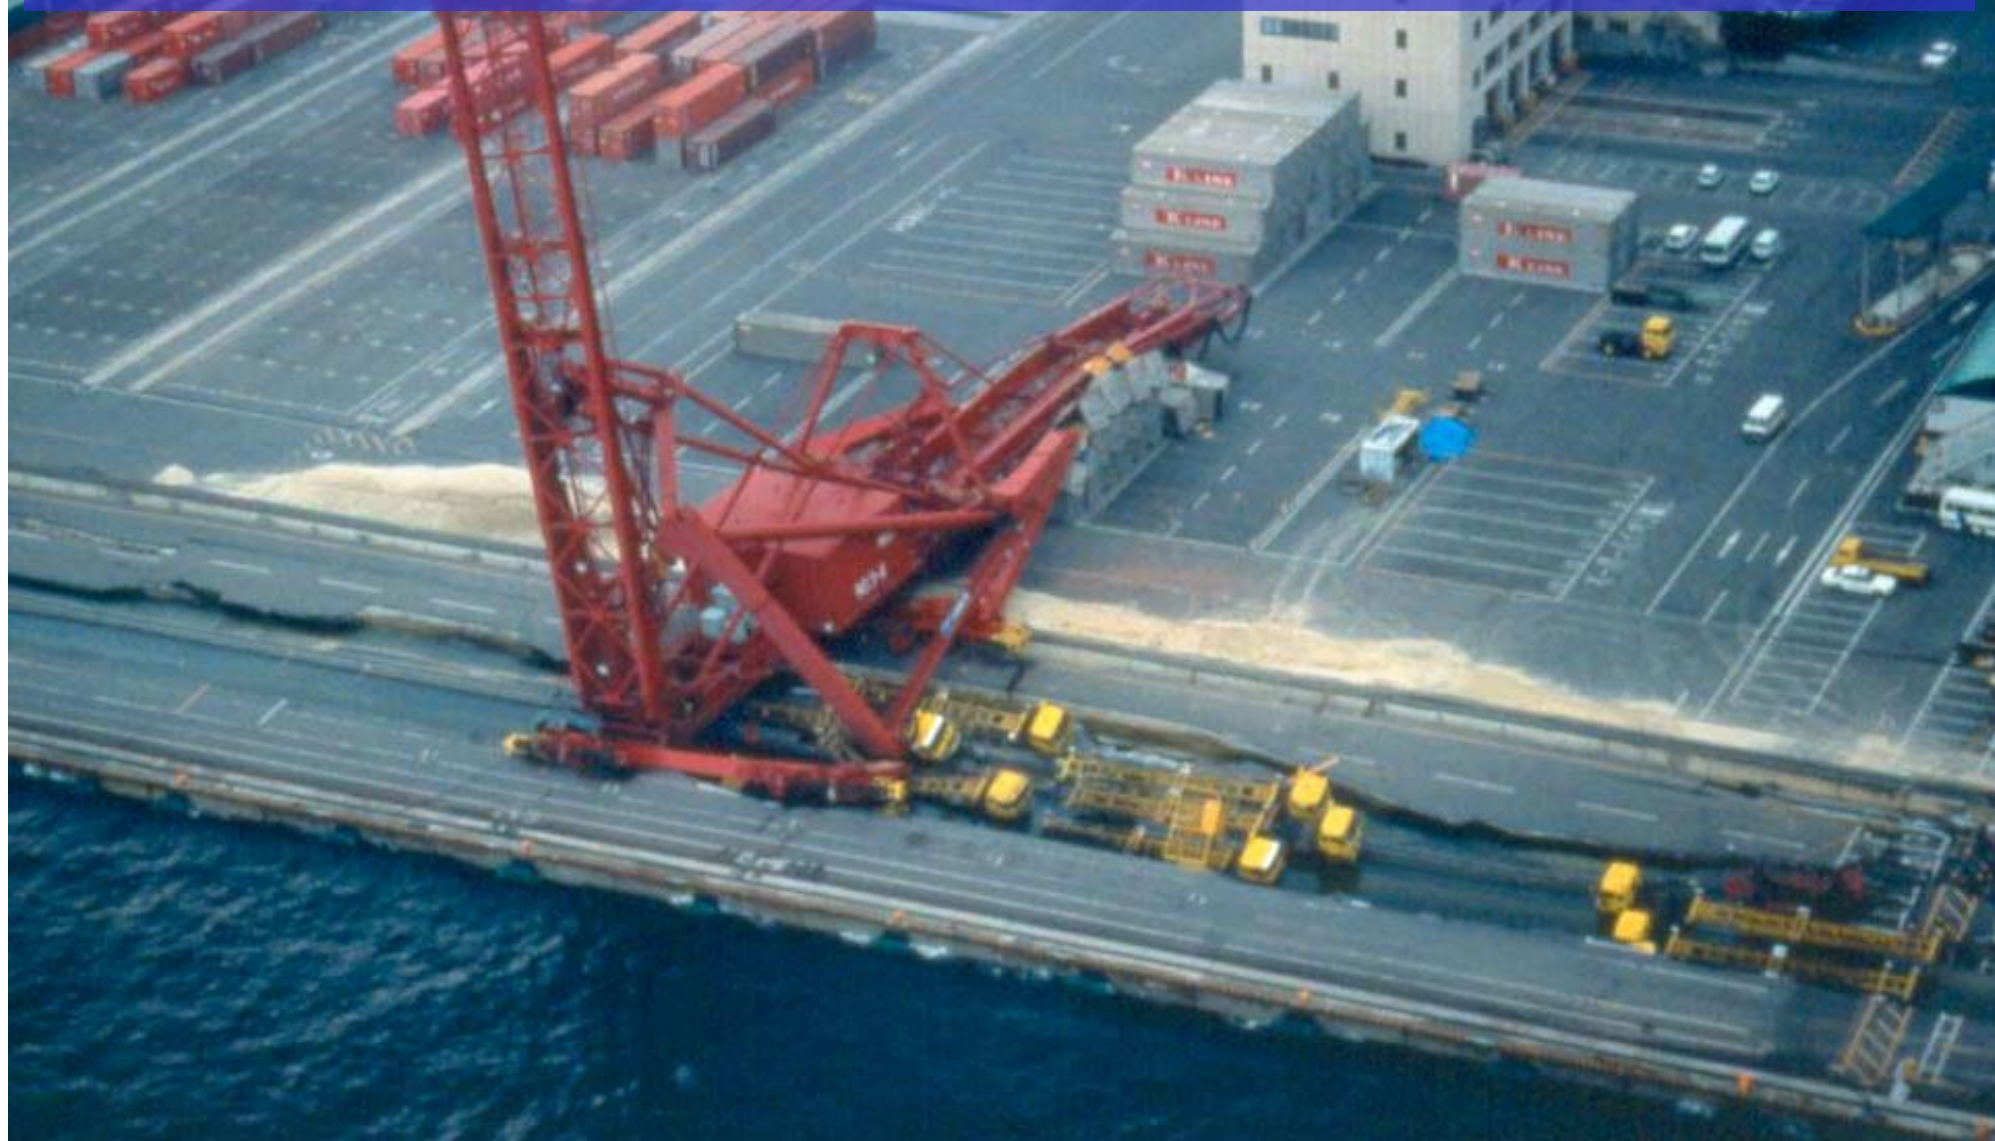
A closer view of the collapsed crane (also visible in the previous photo). The quay wall has displaced outwards and a graben (depression) has formed behind it. The cranes had their legs spread apart, causing buckling and yielding, and collapse in this case. A series of yellow trucks were caught in the graben.

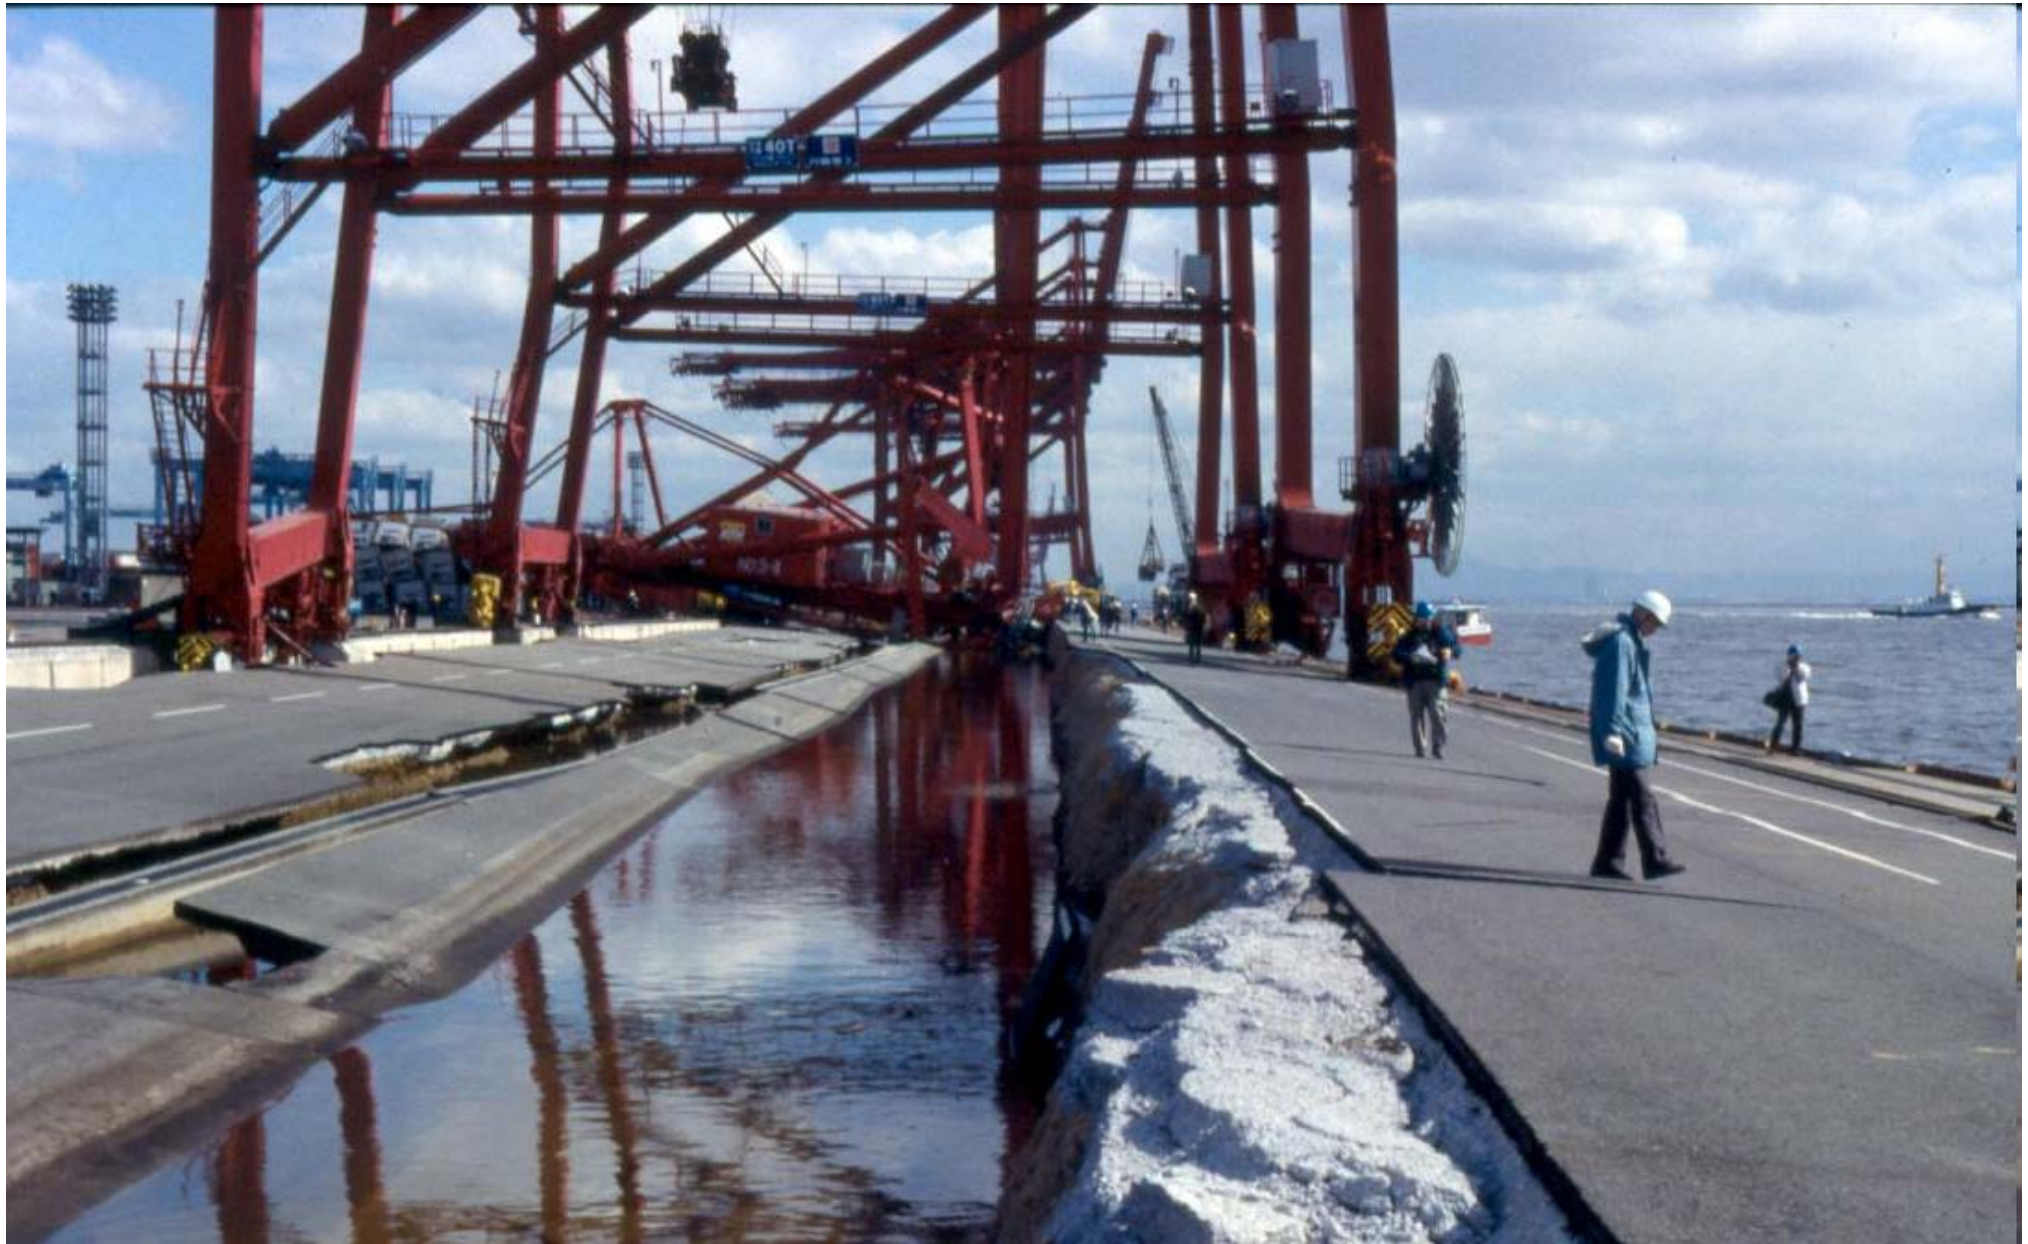
A view of the graben from the top of the quay wall. The collapsed crane is visible in the background. The rear legs of the two closest cranes are locally buckled and off their rails.

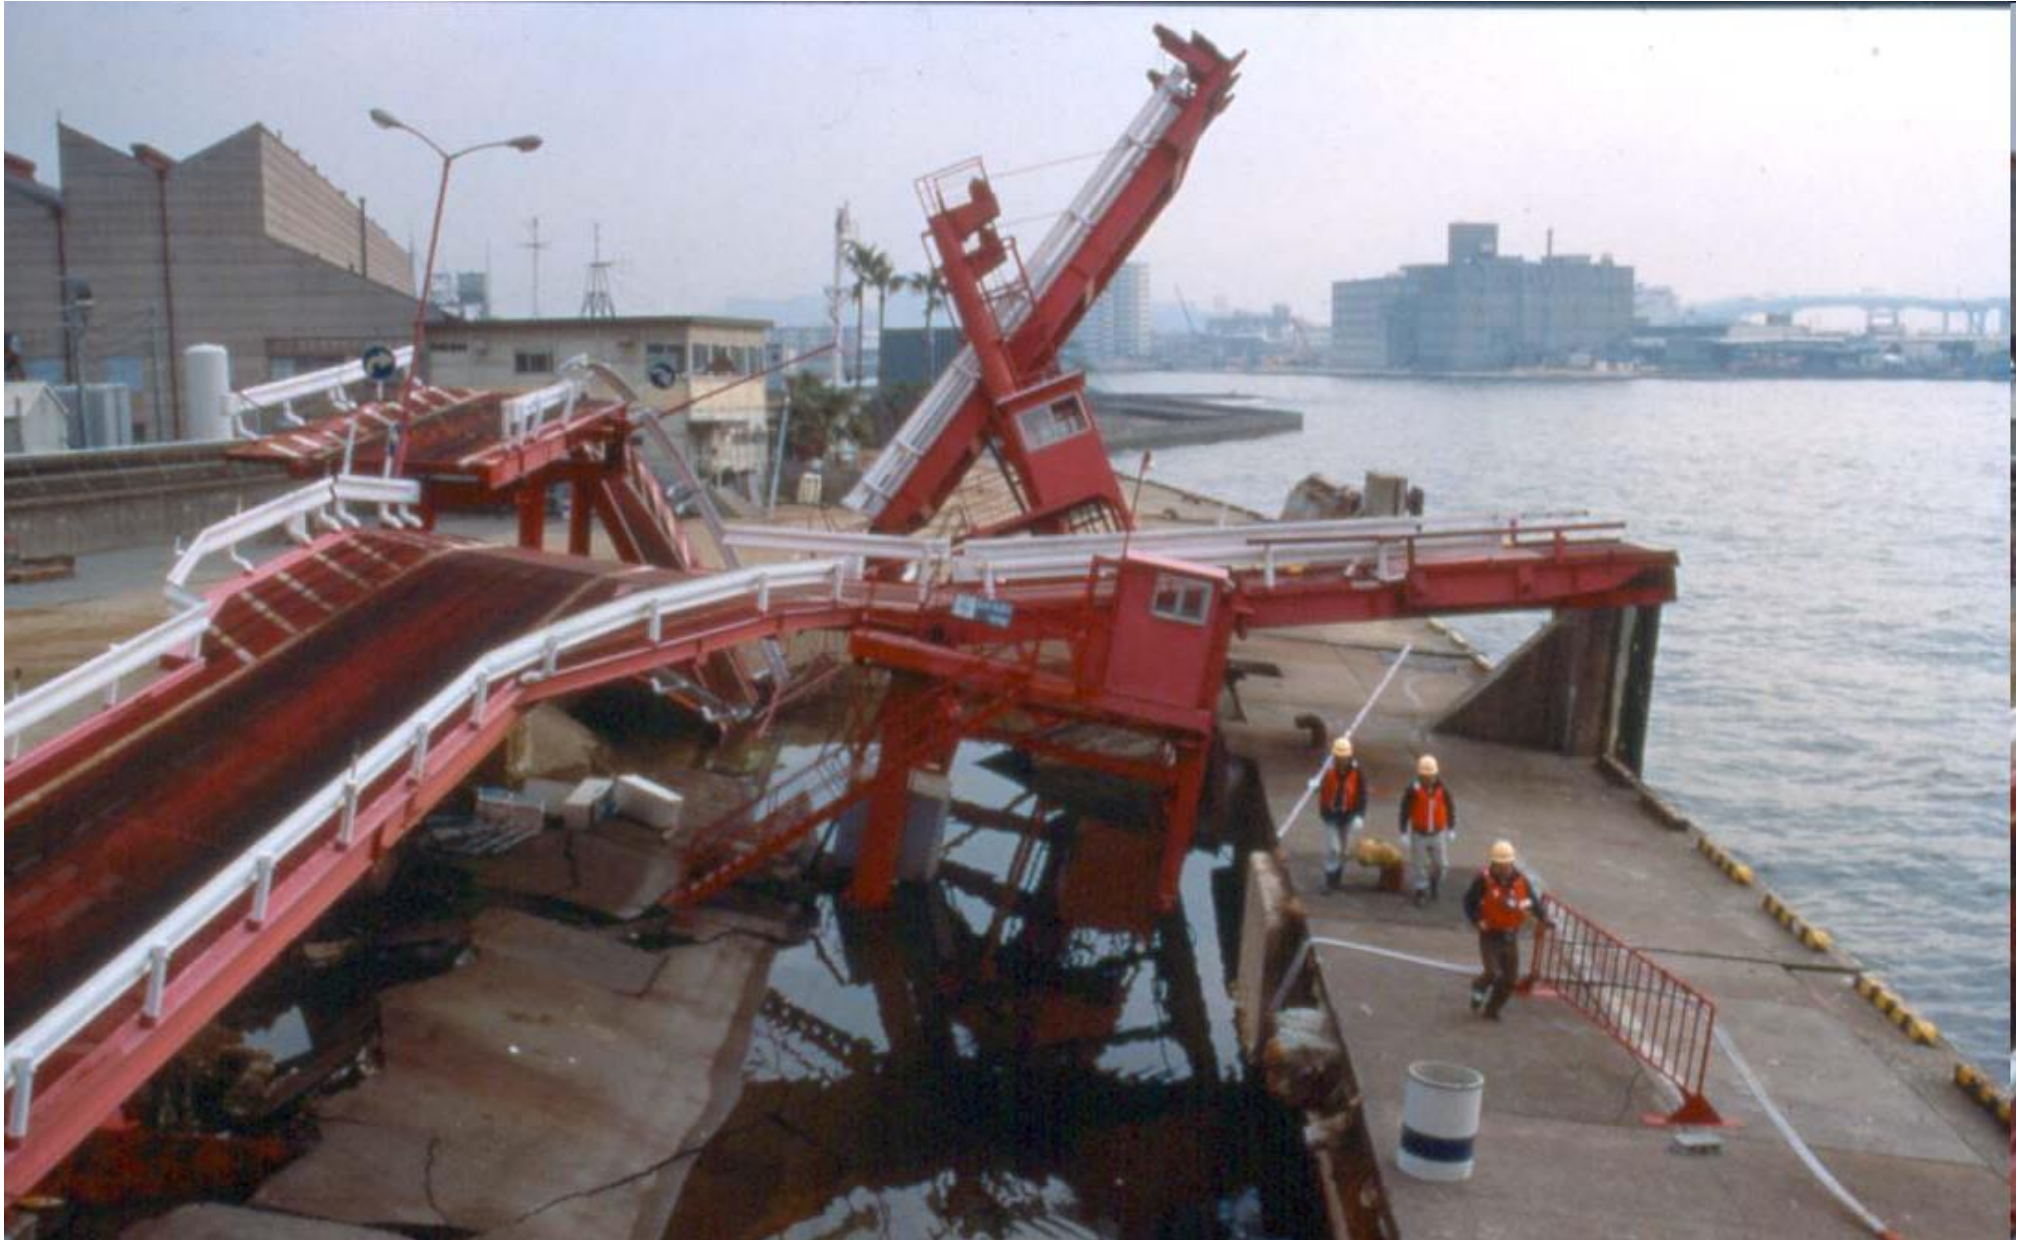
This car ramp at a ferry terminal collapsed when the fill materials liquefied and the quay wall displaced outwards. The graben behind the quay walls is filled with water.
